RELEASE NOTES:

Web OS™ 10.0

Part Number: 212776-B, November 2003

NORTEL
NETWORKS™

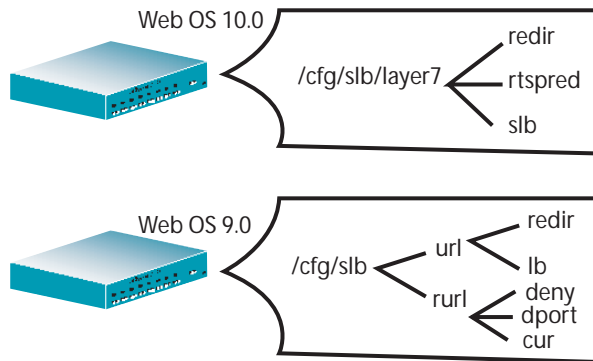
Figure 1 Menu changes in Web OS 10.0 versus Web OS 9.0

To make the CLI more intuitive in the Web OS 10.0 software, some of the configuration menus in Web OS 9.0 have been reorganized. For example, [Figure 1](#) shows the menu changes in the `/cfg/slb` menu.

You will notice some discrepancies if you perform the `diff flash` command *immediately* after you upgrade to Web OS 10.0. To ensure the previous configurations are saved, make some minor configuration changes and then perform an `apply` and `save`.
